Oil Tanker Simplified Fatigue Assessment with Inspection and Repair Approach and Parameters

Ozgur Ozguc

The occurrence of cracks in the hull structure of oil tankers is an important concern for the maritime industry because crack propagation will reduce collapse strength of deck-stiffened panels and, consequently, decrease the ultimate hull girder capacity of ship's structures. Fatigue is an important design criteria for ships to ensure a sufficiently high safety level. Fatigue life predictions of ship's structural details have traditionally been carried out using S-N approach and the Palmgren-Miner's rule. The principal objective of such approach is to estimate the time to failure in order to ensure a satisfactory design lifetime of ship's structural components. Potential cracks are considered to occur in the side shell, in the connections between longitudinal stiffeners and transverse web frame. The main objectives of the present study are to evaluate the fatigue life of vessel's amidships using the simplified fatigue method, which is based on DNVGL-CG-0129 "Fatigue Assessment of Ship Structures" in order to determine the main cause of the observed cracks on the single

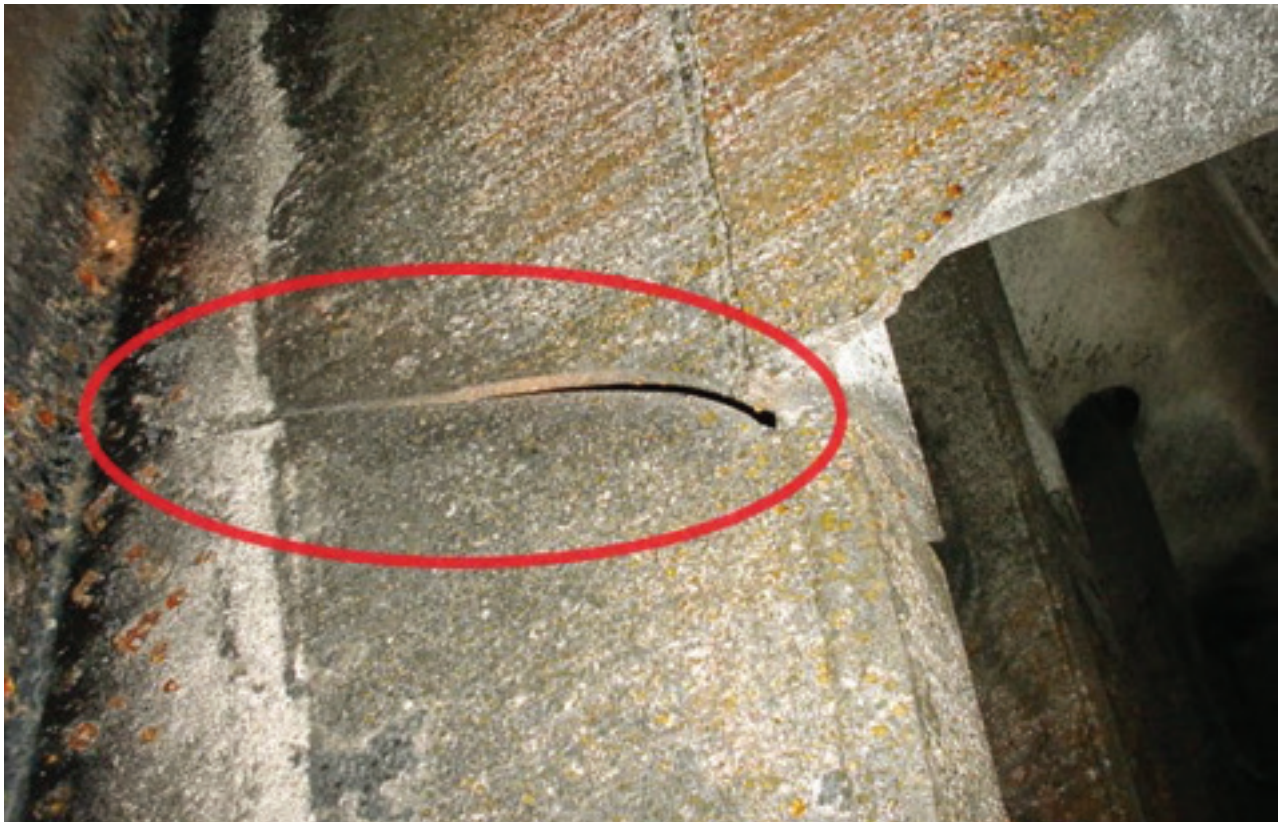
Figure 1.

Many cracks in the side shell were detected at the tripping brackets in both the cargo and ballast tanks. Figure 1 shows that the crack was initiated in the weld between the bracket toe and the stiffener flange. According to the operational information, most cracks were found in the side shell both in ballast and cargo wing tanks, and a few cracks were found in the longitudinal bulkhead at center cargo tank. The cracks in the side shell stiffeners propagated through the stiffener web and into the side shell plating. Further, the design shows that all tripping brackets in the side shell were welded with overlap to the side longitudinals. This increases stress concentration and reduces fatigue life significantly (up to 40 %).

Based on previous experience with large tripping brackets, large brackets represent large local stiffness. Relatively high stress concentration factors were found in the bracket toe and heel. Normally, the heel of brackets is the worst hot spot of one-side bracket details, but no cracks were discovered in the heel for the tripping brackets on this ship. Experience with tripping brackets on other vessels indicates that these details may crack in the toe as well as in the heel (Tanker Structure Co-operative Forum, 2011).

A typical crack at the toe of the tripping bracket (Tanker Structure Co-operative Forum, 2011).

A few tripping brackets in the side shell were repaired over the last two years. The longitudinal stiffeners were partly cropped out and renewed. New triangular brackets (350 x 350 mm) were inserted at the bracket toes. The details that cracked are close to the neutral axis, and both vertical and horizontal bending moments will give small contributions. The lateral dynamic pressure is small as long as both the center cargo tank 7 and wing cargo tank 5 are either full or empty.

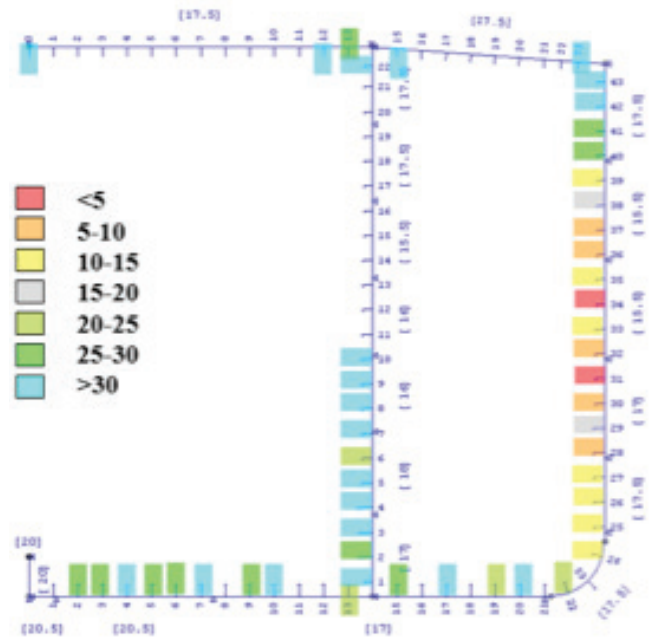
Figure 8.
Representative fatigue lives for frame 240, representing a typical frame in the ballast wing tank amidships.

The fatigue lives in the side shell longitudinals are below 20 years. 20 years are normally regarded as a fatigue target life for new designs. Longitudinal L31 and L34 have fatigue lives below 5 years. These tripping brackets have already cracked at some locations. In addition, longitudinal L28, L30, L32, L36 and L37 have fatigue lives well below 20 years.

The external dynamic sea pressure is the dominant part in the fatigue life calculations of the side shell stiffeners. Other effects such as internal pressure and horizontal bending moment contribute to fatigue, but the main cause is the external pressure. The external pressure taking the dynamics in the splash zone (partly dry, partly wet area with the passing waves) into account gives the largest fatigue loads just below the still water line. In addition, the external pressure at the fully loaded condition contributes slightly more than the ballast condition to the fatigue lives in the side shell. The still water line for fully loaded condition is located approximately at L37. The fatigue life pattern shows a typical behavior when the external pressure dominates the fatigue damage.

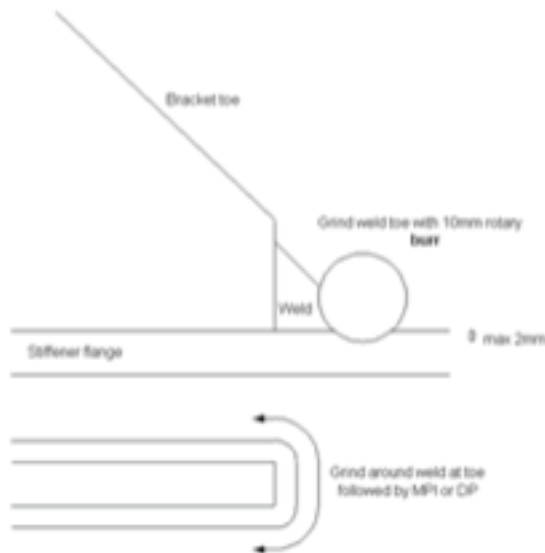
Figure 10.
Principle of bracket toe grinding followed by DP or MPI (IACS, 2017).

For the bracket toes, the inspection proposed is shown schematically in Figure 10. In principle, this will be the same for the brackets with overlap, as shown in Figure 11.

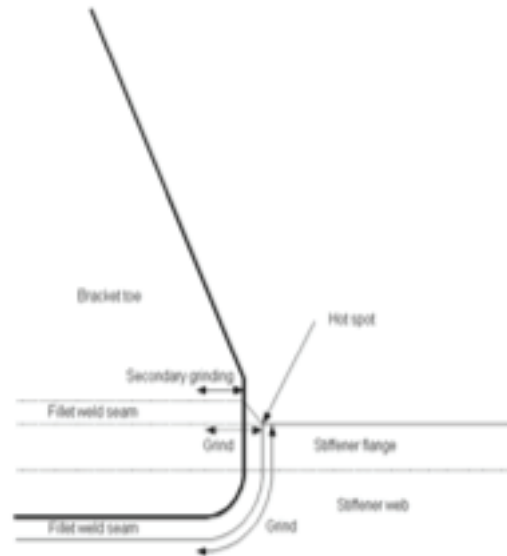
Figure 11.
Proposed grinding for bracket toes with overlap (IACS, 2017).

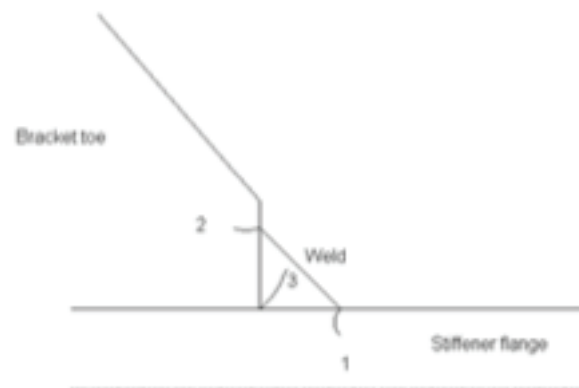
The crack may initiate in principle at three different locations as seen from Figure 12. It should be noted that the intention of the grinding above is to improve the fatigue life of the detail by removing the crack at location 1. The grinding procedure may reduce the fatigue life at location 3, while the fatigue life of location 2 will be unchanged. For the scallops the grinding is proposed as shown in Figure 13. Grinding of the scallops for brackets with overlap is similar as shown in Figure 14.

Figure 12.
Crack location of welds.

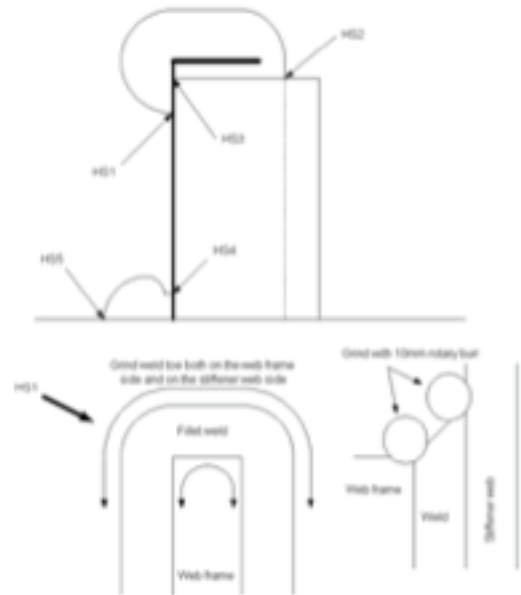
Based on the above, the slots should be checked for the details shown with grey, yellow, orange and red boxes, with special emphasis on the slots at the lower part of the web frame. For midship frames, special emphasis should be given to longitudinal L30 to L34 in the side shell. Typical hot spots to be checked are presented in Figure 15. This slot represents type "J" on the midship drawing, which seems to be a quite good detail except for hot spot 1 (denoted HS1) and hot spot 2. Hot spot 4 is of the recommended design used in order to move the stress flow away from the toe.

Figure 15.
Typical critical hot spots for slot of the "J" type.

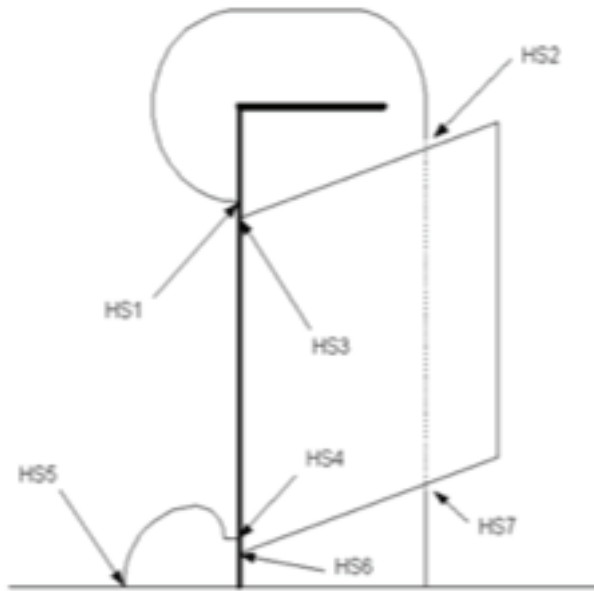
Similarly, the slot of type "H" is also used in the critical areas. This is presented in Figure 16. Typically, HS1, HS2 and HS3 will be the worst. There are also a few other details of concern that were not investigated in the present fatigue analysis, but which may crack according to experience with similar vessels. The first detail is the bracket toe of the large brackets on the web frame, schematically shown in Figure 17. Hot spot HS2 will normally be the worst since it is exposed to the largest external pressure, but also the other three might be critical. The rest of the bracket toes in the frame are less critical.

Figure 16.
Typical critical hot spots for the slot of "H" type.

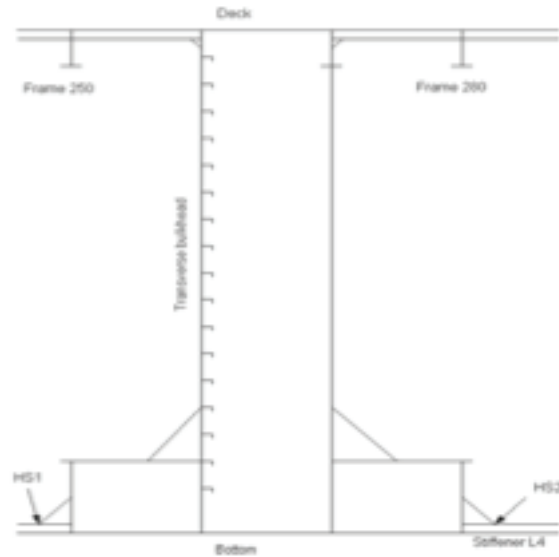
Figure 18.
Vertical girder at the transverse bulkhead and two critical details.

toe detail exposed to relative deflection, as shown in Figure 18.. The relative deflection effect is small for the bottom stiffeners; however, it is connected to a detail with significant longitudinal stiffness, hence these two effects make this detail probably the worst detail in the bottom. It is proposed to check the bracket toes at HS1 and HS2 at the transverse bulkhead, Frame 260.
