Methods of Pollution Removal after Tanker “Erika” Accident

Ivan Čović, Anamarija Šimunac, Jelena Veža, Merica Slišković, Gorana Jelić-Mrčelić

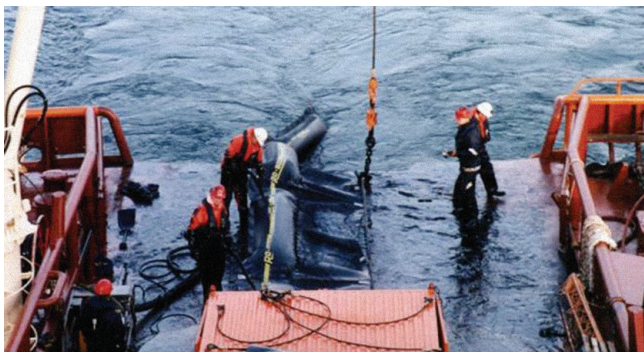
Figure 2. Heavy fuel attached to the deck of a vessel.

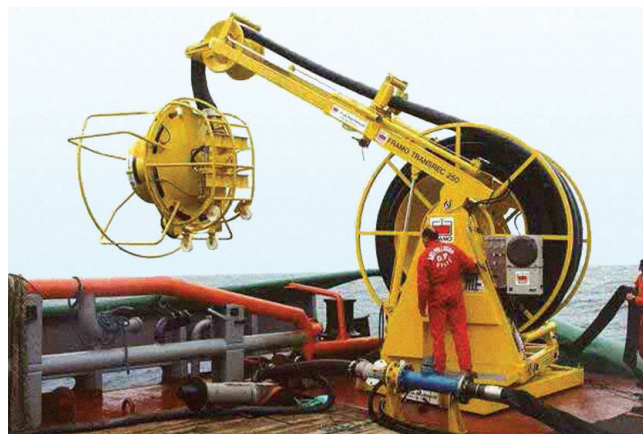
Figure 4. *Transrec* 250 skimmer.

The TRANSREC 250 is a combined oil recovery and transfer system with self-containing abilities, used to contain spilled oil, in oil recovery operations and to offload oil from grounded vessels. It is equipped with portable offloading hydraulic pumps capable of transferring fuel oil to recovery vessels or any other type of storage facility available at the clean-up site. The pump is used primarily to offload oil trapped inside a damaged vessel. The recovery unit of *Transrec* 250 is a combination of free-floating weir skimmer and subsidiary disc and belt cassettes. Disk cassettes are used for recovering thin oil slicks, while the belt

skimmer cassette is used for recovering high-viscosity oil slicks. The head of the skimmer is connected to a hose lifting arm by a floating hose with integrated hydraulic lines, electrical cable and cargo hose. The *Transrec* 250 system has the maximum capacity of 400 m³/h. The hose of the *Transrec* 250 skimmer has an internal diameter of 5 inches and is approximately 80 m long. These two characteristics were the main reason for constant pressure losses hindering oil recovery operations. Also, the skimmers were not successful due to the thickness of the oil stain and its characteristics (30-50 % of water).

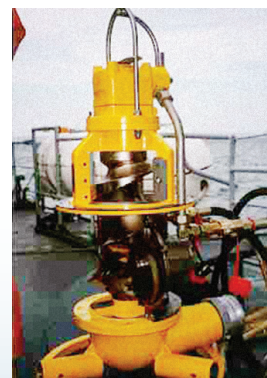
Figure 5.

Foilex 250 skimmer.

system ceased in favour of the beginning of utilization of the *Foilex* TDS 250 weir skimmer fitted with a screw pump - oil collecting equipment of lower capacity than the *Transrec* system (up to 70 m³/h). The *Foilex* TDS 250 consists of a skimmer, hydraulic powerpack and hose package. The skimmer collects the oil into the collecting tank. The deployment of the *Foilex* system was a risky move, but the salvage crew hoped that unpolluted water would be pumped out together with the oil,

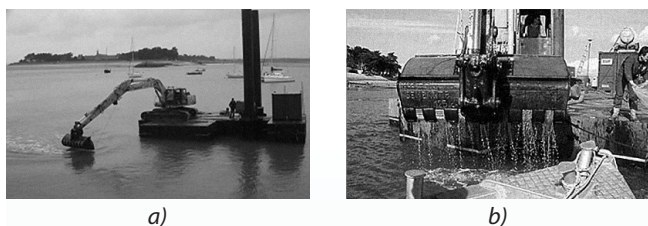
Figure 11. Dredging the centre of the slick where the oil concentration was the highest; a) Mechanical dredger fitted on a floating pontoon; b) Refinement filter.

down the oyster beds and salt pans in the area affected. Since new oil strandings were continuously reported in the area of *Pen Bron* the Government realised that at the entrance to the bay in *Pen Bron Channel* there was an unremoved underwater oil stain causing chronic pollution. The area polluted extended on more than 10,000 m² while the oil stain varied from 0.15 metres in diameter to the oil beads. At the centre of the stain there was an area sized 700 m² where there was a high concentration of sediment and oil mixture. Since the area polluted is subject to strong currents great attention had to be paid to remove even the least possible amount of sediment in order to facilitate the subsequent transport and removal operations. The clean-up operation was divided into two phases. The first phase included dredging of the central part of the oil stain where the oil concentration was highest using mechanical dredgers with filters mounted on pontoons.

This clean-up operation was carried out in ten subsequent days, but only at the time of low water. 800 tons of highly polluted sand was removed from the depth of 30 centimetres. This technique proved to be extremely fast and efficient.
