Oil Tanker Simplified Fatigue Assessment with Inspection and Repair Approach and Parameters

Ozgur Ozguc

The occurrence of cracks in the hull structure of oil tankers is an important concern for the maritime industry because crack propagation will reduce collapse strength of deck-stiffened panels and, consequently, decrease the ultimate hull girder capacity of ship's structures. Fatigue is an important design criteria for ships to ensure a sufficiently high safety level. Fatigue life predictions of ship's structural details have traditionally been carried out using S-N approach and the Palmgren-Miner's rule. The principal objective of such approach is to estimate the time to failure in order to ensure a satisfactory design lifetime of ship's structural components. Potential cracks are considered to occur in the side shell, in the connections between longitudinal stiffeners and transverse web frame. The main objectives of the present study are to evaluate the fatigue life of vessel's amidships using the simplified fatigue method, which is based on DNVGL-CG-0129 "Fatigue Assessment of Ship Structures" in order to determine the main cause of the observed cracks on the single

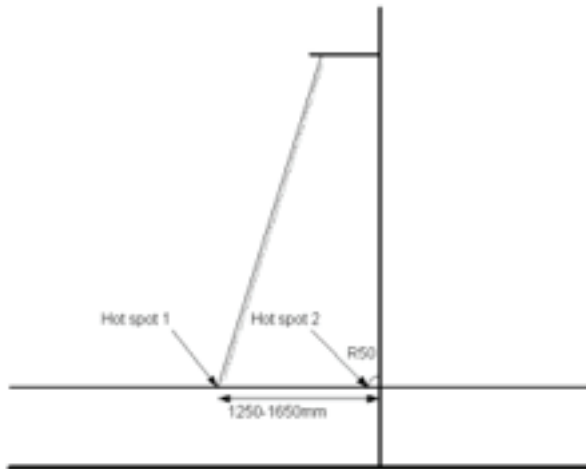
Figure 4. Tripping bracket on top of T-profiles in bottom floors. The scallop is assumed with a radius of 50mm.

For the tripping bracket in the bottom shell shown in Figure 4, the following SCFs are used:

According to the tabulated stress concentration factors (SCF) for tripping brackets given in DNVGL-CG-0129, the highest SCF is located in hot spot 2. Hot spot 1 is given a reduced bending moment from lateral pressure. Maximum bending moment is used for hot spot 1 in the present study (based on experience with large tripping brackets in the finite element analysis). In addition, the crack is observed in the bracket toe instead of the heel. This means that the real SCF is larger at the toe than at the heel. Based on this, hot spot 2 is used to represent the fatigue life for the bracket toe.

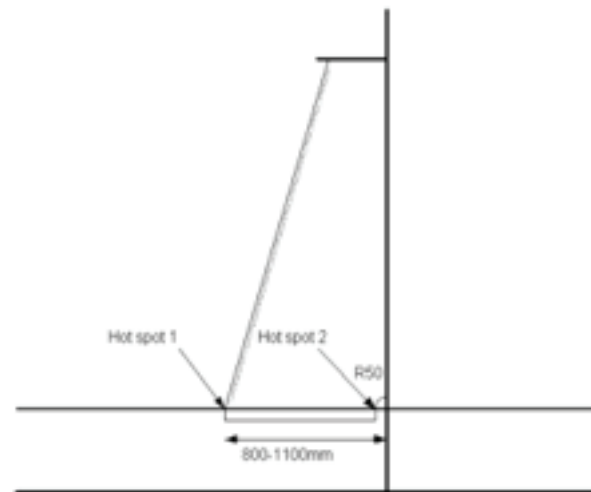
Figure 5. Tripping bracket with overlap (L-profiles) located at deck, side and longitudinal bulkhead.

For the tripping bracket in the side, deck, and longitudinal bulkhead shown in Figure 5, the following SCFs are used:

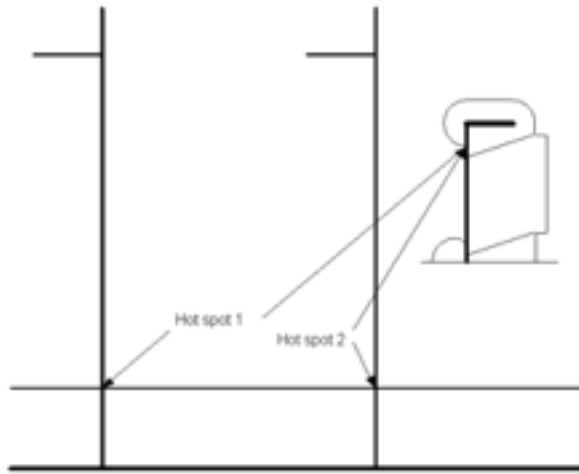
Figure 6.
Typical transition detail at deck, side, and longitudinal bulkhead.

For the transition detail in side, deck, and longitudinal bulkhead shown in Figure 6, the following SCFs are used:

Hot spots 1 and 2 will have the same fatigue life and represent the same hot spot on two different frames. It should be noted that these SCFs represent the SCF in the web of the longitudinals and not the web frame scallops. The K_n factor depends on the L-profile dimensions and varies between 1.3 and 1.8.

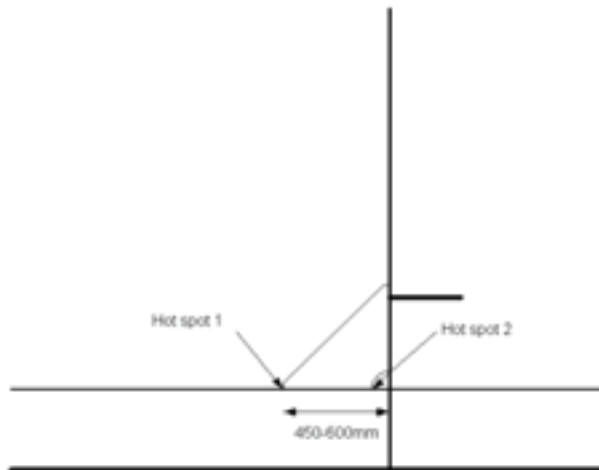
Figure 7.
Common bracket in bottom and side.

The last detail is a common bracket detail. A detail without overlap typical for bottom longitudinals is presented in Figure 7. For the common bracket detail, the following SCFs are used:

For the details with overlap, the K-factors are multiplied with the factor of 1.15. The factors become the same as for the tripping bracket with overlap. The main difference is that the maximum stiffener bending moment is located 2/3 of the length into the bracket. This means that the moment at the bracket toe is lower, where a reduction factor r_p is used from DNVGL-CG-0129. Hot spot 2 then becomes significantly worse than hot spot 1. At

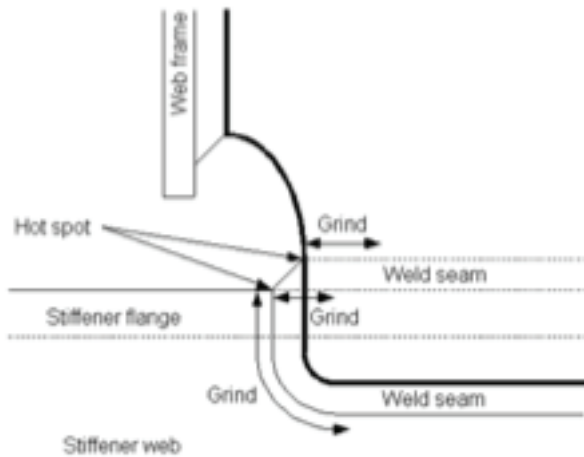
Figure 13.
Proposed grinding for scallops with overlap (IACS, 2017).

The crack may initiate in principle at three different locations as seen from Figure 12. It should be noted that the intention of the grinding above is to improve the fatigue life of the detail by removing the crack at location 1. The grinding procedure may reduce the fatigue life at location 3, while the fatigue life of location 2 will be unchanged. For the scallops the grinding is proposed as shown in Figure 13. Grinding of the scallops for brackets with overlap is similar as shown in Figure 14.

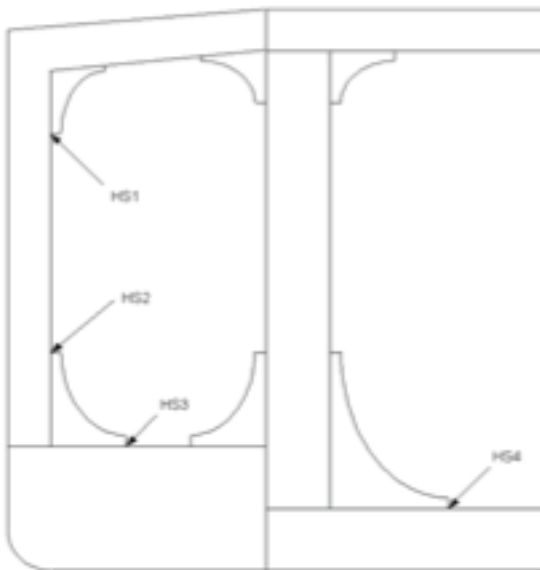
Figure 18.
Vertical girder at the transverse bulkhead and two critical details.

toe detail exposed to relative deflection, as shown in Figure 18.. The relative deflection effect is small for the bottom stiffeners; however, it is connected to a detail with significant longitudinal stiffness, hence these two effects make this detail probably the worst detail in the bottom. It is proposed to check the bracket toes at HS1 and HS2 at the transverse bulkhead, Frame 260.
